EFFECTS OF LOW EARTH ORBIT ON THE OPTICAL PERFORMANCE OF MULTILAYER ENHANCED HIGH REFLECTANCE MIRRORS*

ABSTRACT

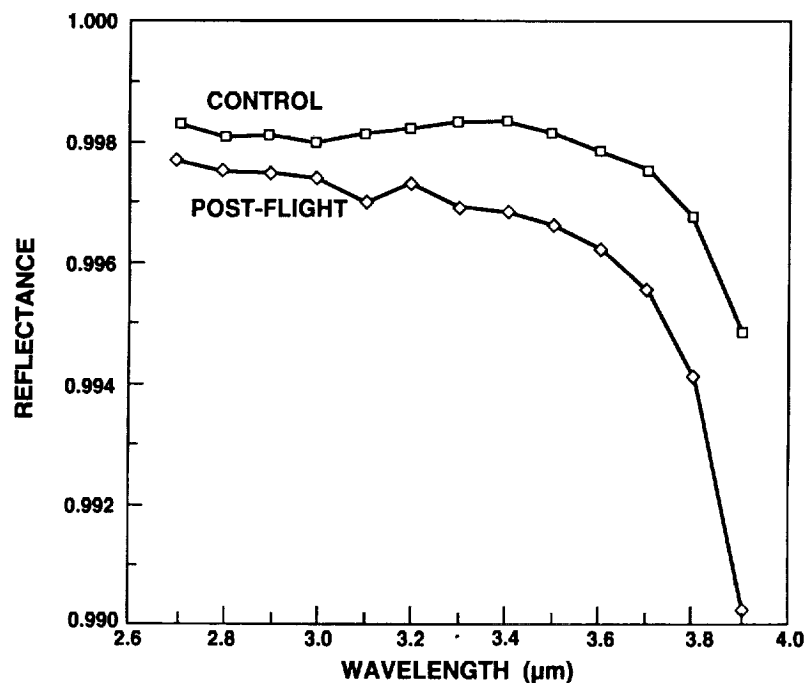
The spectral reflectance of the leading-edge $(Si/Al_2O_3)^3Ag/Si$ test sample after 90 days exposure to the effects of low-Earth orbit (LEO) is shown in Figure 1. As seen in the figure, the reflectance of the test sample is reduced less than 0.1% at the design wavelength (2.8 μm) relative to the laboratory control. The reflectance of the control was reduced by less than 0.1% after 10 years on the laboratory shelf. Profilometer measurements showed that increases in optical scatter resulted from surface debris and not

from changes in microstructure or topography. The scatter increase contributed to the small reflectance loss relative to the control.

Figure 1. Post-flight reflectance of the leading-edge $(Si/Al_2O_3)^3Ag/Si$ test sample compared to a laboratory control. The reflectance loss of the test sample relative to the control is less than 0.1% at the design wavelength (2.8 μm).

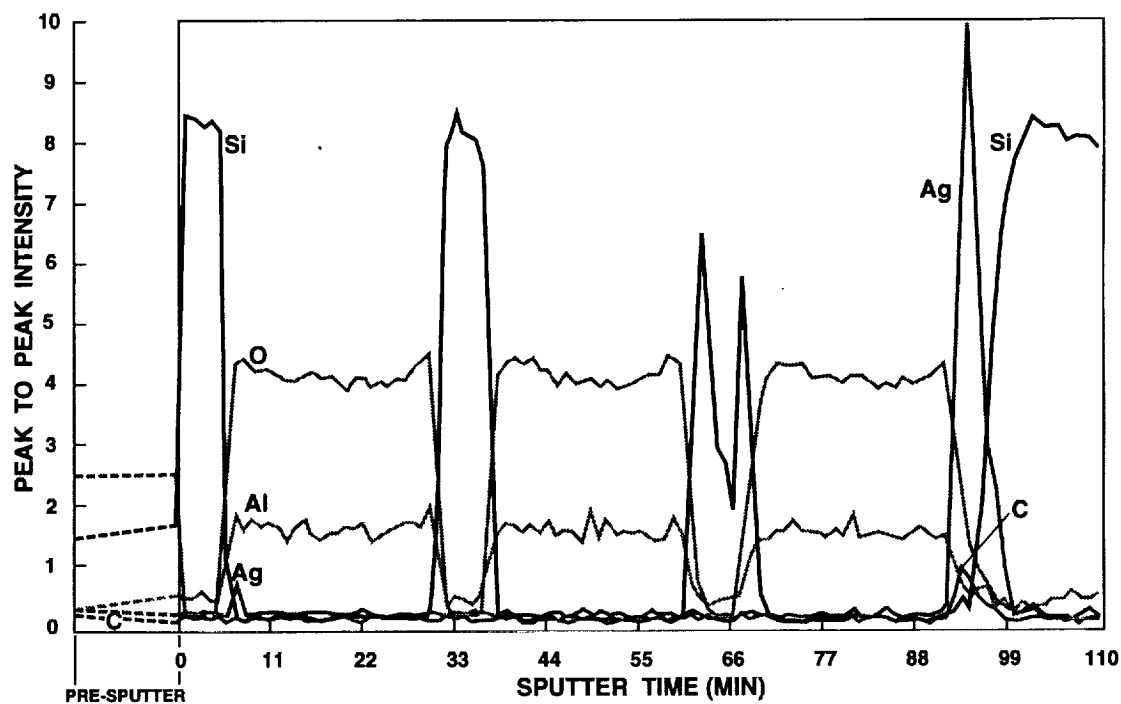
Auger profiles of the test sample are shown in Figures 2 and 3. The depth profile (Figure 2) reveals the design; three Si/Al_2O_3 high/low index pairs, a Ag reflectance enhancing layer, and the silicon substrate. Some charging occurred during sputter etching of the third silicon layer but the thicknesses are fairly uniform. Note the small Ag peak at the outer Si/Al_2O_3 interface and a C contamination peak at the Al_2O_3/Ag interface.

Figure 2. Post-flight Auger depth profile of the leading-edge $(Si/Al_2O_3)^3Ag/Si$ test sample showing uniform layer thicknesses. Distortion of the third Si layer peak is due to surface charging.

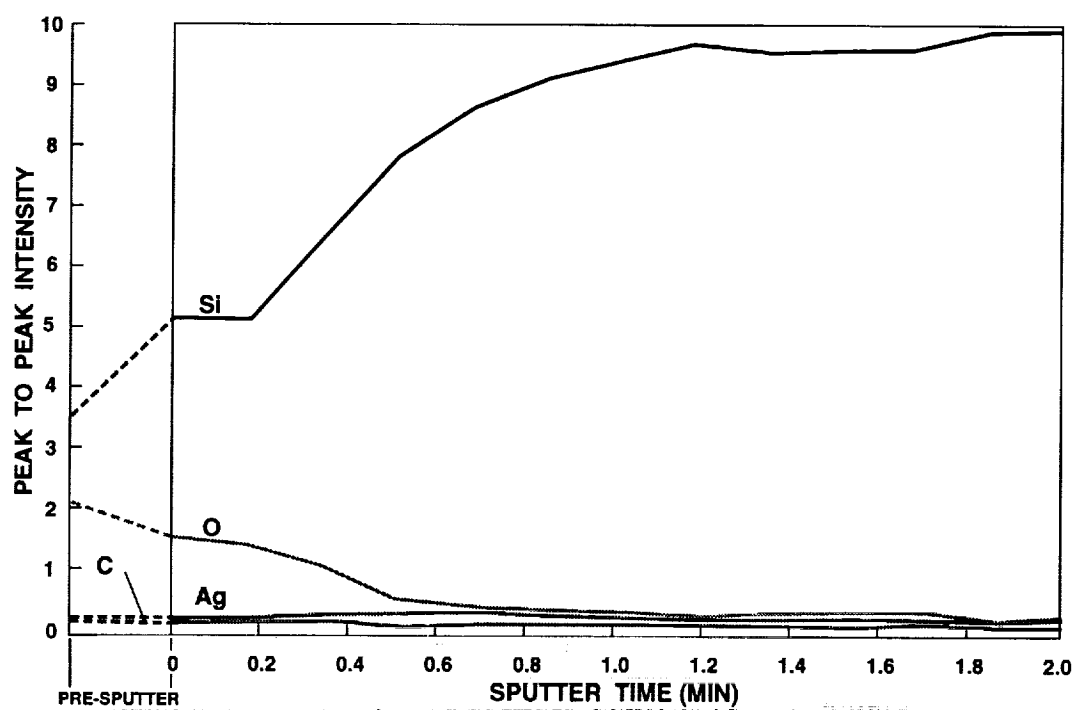
An Auger surface profile is shown in Figure 3. The estimated sputter rate and time to when oxygen reaches the background level indicates approximately 36 Å of surface oxide. This is within a factor of two of what one would expect from a natural oxide layer on silicon. It is noted that the small growth rate relates to the atomic oxygen (AO) flux at the deployment altitude (476 km) and the short exposure (3 months). This thickness will have little effect at the design wavelength but could account for a slight increase in absorption at wavelengths greater than 3 μm.

Figure 3. Post-flight Auger surface profile of the leading-edge $(Si/Al_2O_3)^3Ag/Si$ test sample. The thin surface oxide layer indicates that Si is not significantly degraded by the energetic AO encountered in LEO.

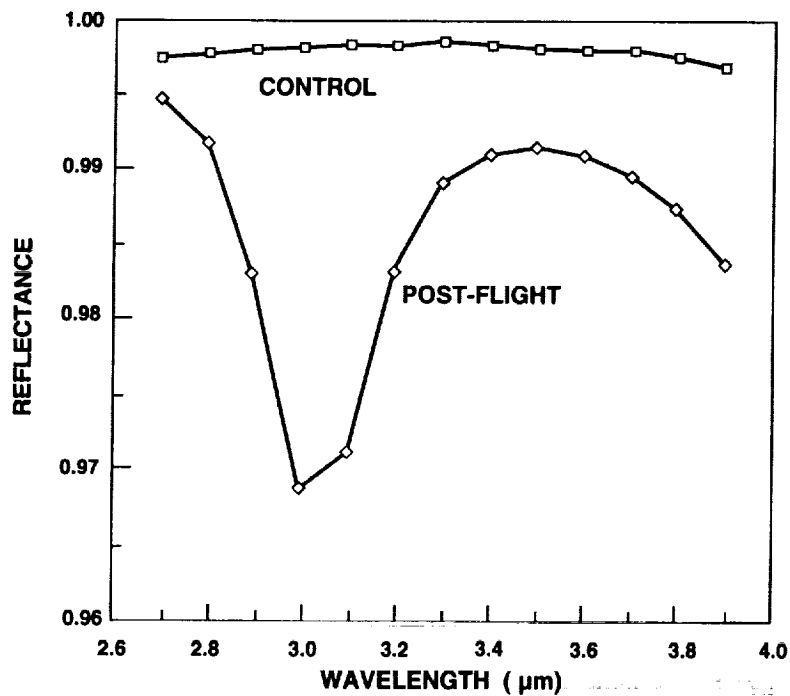
The post-flight reflectance of the leading-edge $(ZnS/Al_2O_3)^4Ag$ test sample compared to a laboratory control is shown in Figure 5. The mirror was exposed for nine months beginning with the deployment of LDEF. The test sample has an absorption band centered at 3 μm which reduces the reflectance at the design wavelength of 2.8 μm. The control has no similar loss.

Surface profilometry measurements show an increase in roughness (and related scatter) compared with preflight data. The increase is due to some degradation of the coating surface, debris, and the presence of dendritic material. The scatter, degraded material, and areas of dendritic growth, however, do not account for the spectral feature.

Figure 5. Post-flight reflectance of the leading-edge $(ZnS/Al_2O_3)^4 Ag/Mo$ test sample compared to a laboratory control.

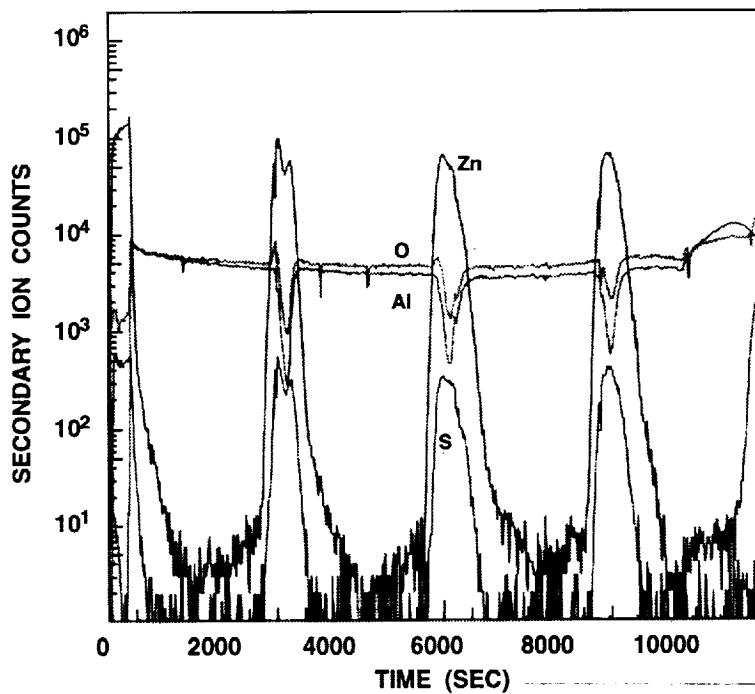
A depth profile of this sample taken by SIMS is shown in Figure 6. Sputter etching was accomplished using O⁻ primary ions to minimize charging effects. The layers are uniform in thickness and there are no significant deviations from the quarter-wave design to account for the spectral band, suggesting the absorption is due to water contamination. Unfortunately, an analysis of H and O couldn't be obtained by sputtering with O⁻ primary ions.

Figure 6. SIMS depth profile of the leading-edge $(ZnS/Al_2O_3)^4 Ag/Mo$ test sample showing uniform layer thicknesses.

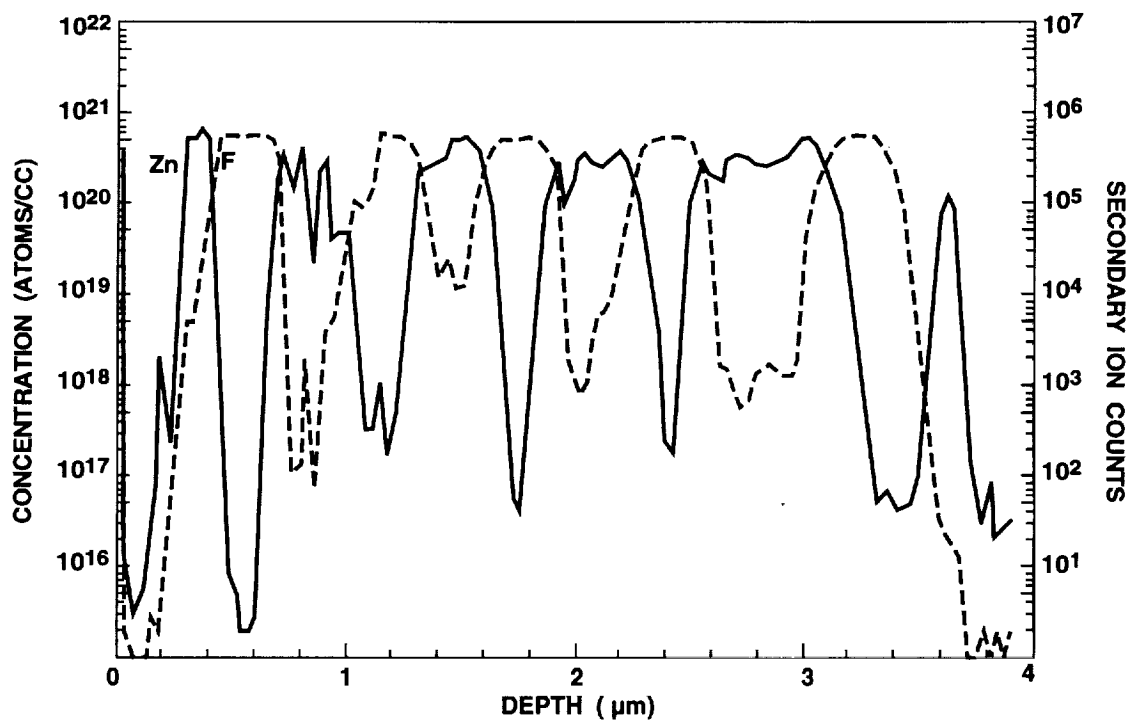
Similar spectral bands, in this case centered at 2.9 μm, are observed in the post-flight reflectance data of both leading- and trailing-edge ZnS/ThF₄ test samples. SIMS profiling data is shown in Figure 7 for the leading-edge sample. Here, atomic concentration versus depth is plotted with sputter time converted to depth with stylus profilometry using the assumption that ZnS and ThF₄ sputter at equal rates. Sputter etching was accomplished in this case with Cs⁺ primary ions, which can be used to determine H and O. Charging is somewhat of a problem with Cs⁺, but the data is in qualitative agreement with Auger profile data[1] which also shows a relatively thin surface and thick base layers of ZnS.

Figure 7. SIMS depth profile of the leading-edge $(ZnS/ThF_4)^5Ag/Mo$ test sample showing a thin surface layer and thick base layers of ZnS.

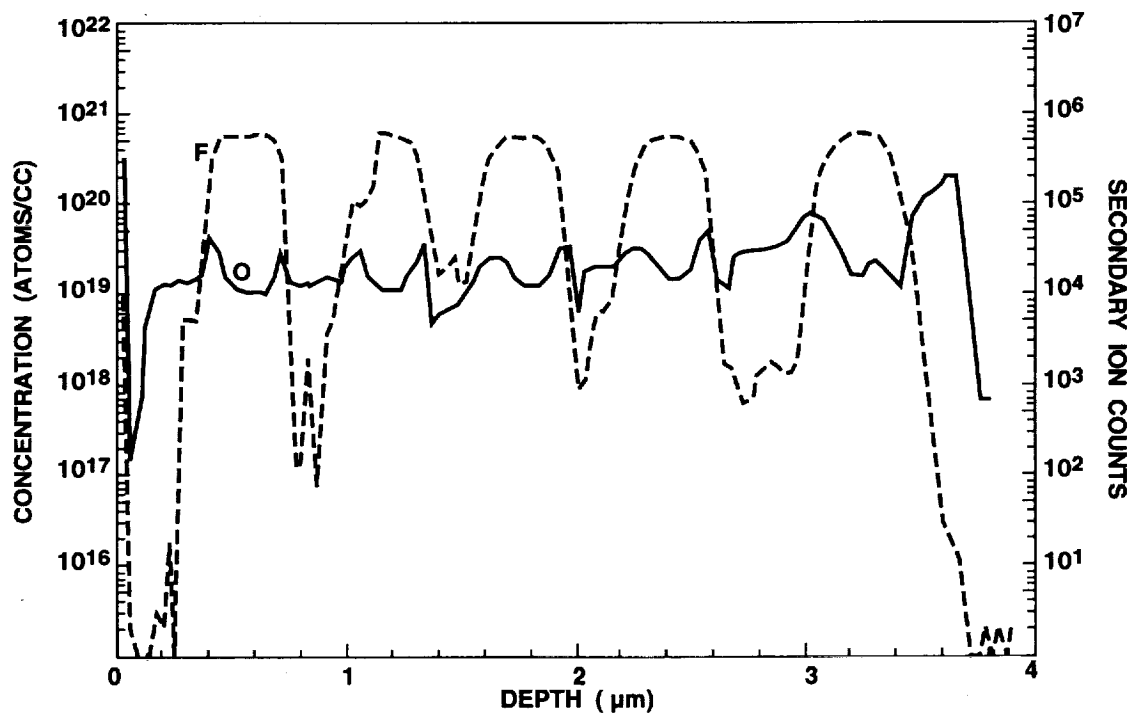
SIMS depth profiles of O and H are shown in Figures 8 and 9, respectively, for this sample. Calibration in terms of atomic concentration was done using data from float-zone-refined silicon. Note the presence of H and O in the ThF₄ layers with tendency of both materials to peak at high/low index interfaces. Also, concentrations of O and particularly H tend to increase with depth into the coating. It is possible that water contamination incorporated during fabrication was ionized in the radiation environment of LDEF and moved to the film interfaces driven by a reduction in free-energy.

Figure 8. SIMS depth profile of the leading-edge $(ZnS/ThF_4)^5Ag/Mo$ test sample. The O concentration peaks at the interfaces and increases with depth into the coating.

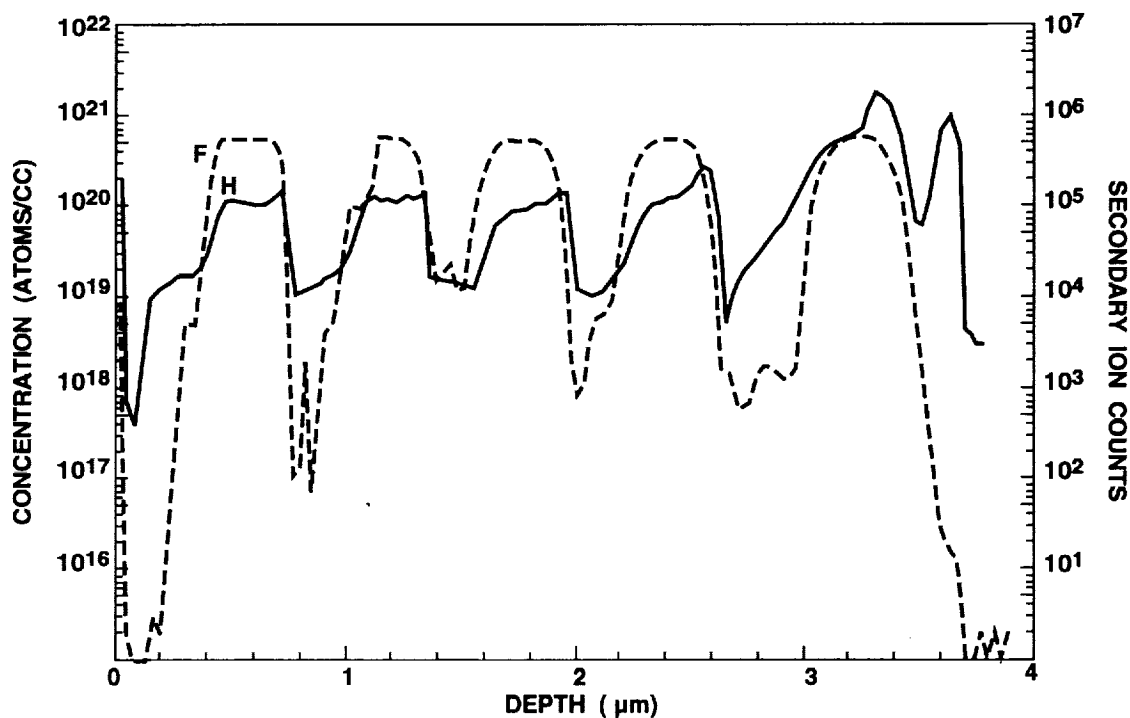
Figure 9. SIMS depth profile of the leading-edge $(ZnS/ThF_4)^5Ag/Mo$ test sample. The H concentration is high in the ThF_4 layers and increases with depth into the coating.

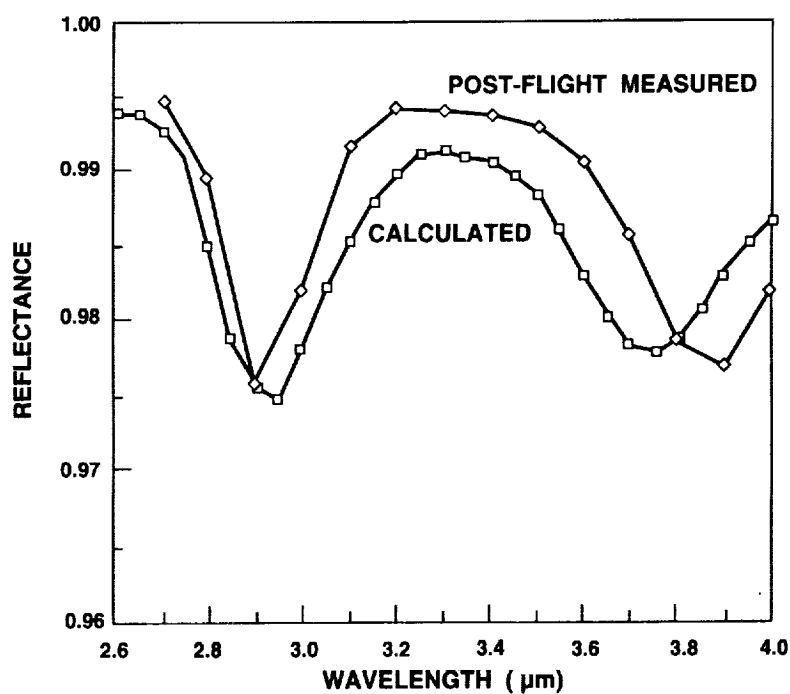
The calculated spectral reflectance values are compared with post-flight reflectance data in Figure 10. As seen in the figure, the SIMS data gives an excellent fit to the reflectance spectrum in the 2.9 to 4.0 μm region. This result validates preflight simulations of combined solar-UV/charged-particle radiation at the Boeing Radiation Effects Laboratory[2] which showed that the irradiation of water-contaminated ZnS/ThF$_4$ multilayers increased the optical absorption about 1% at 2.9 μm.

Figure 10. Measured post-flight reflectance of the leading-edge $(ZnS/ThF_4)^5Ag/Mo$ test sample compared to a calculated reflectance curve. Thin layers of water contamination at film interfaces and layer thicknesses derived from the SIMS data shown in Figures 7-9 were used to match the calculated to the measured reflectance curve.

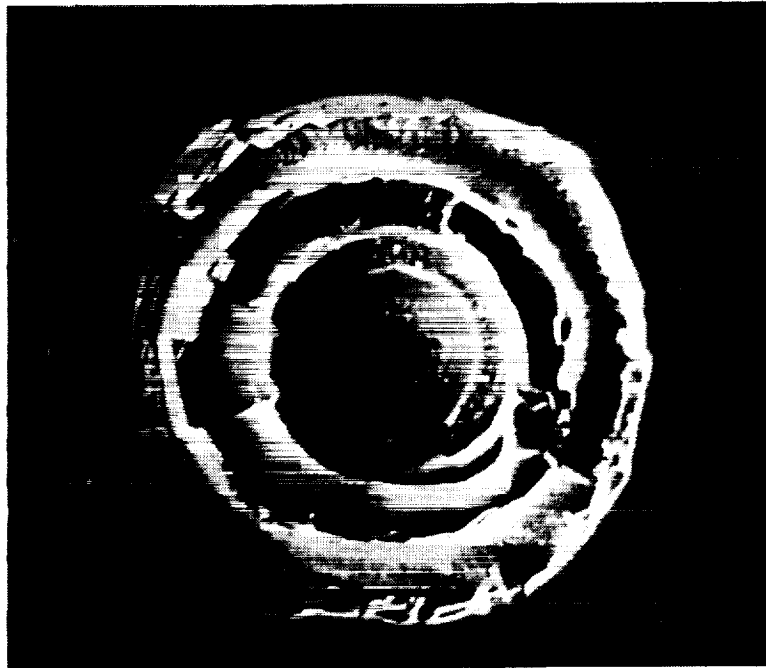
Figure 11 shows one of two craters formed by high-velocity impact on leading-edge sample L6-VI-7-68-15. This crater is about 70 μm in diameter and about 3.5 μm deep and was formed by a particle approximately 10 μm in diameter. The multilayer structure is exposed, revealing melt and some undercutting of the individual layers suggesting their vulnerability to attack by solar UV/atomic oxygen. An analysis was not performed for possible residual material from the impacting particle.

Figure 11. Scanning electron micrograph of impact crater on leading-edge $(ZnS/ThF_4)^5 Ag/Mo$ test sample revealing the multilayer structure and melt of individual layers.

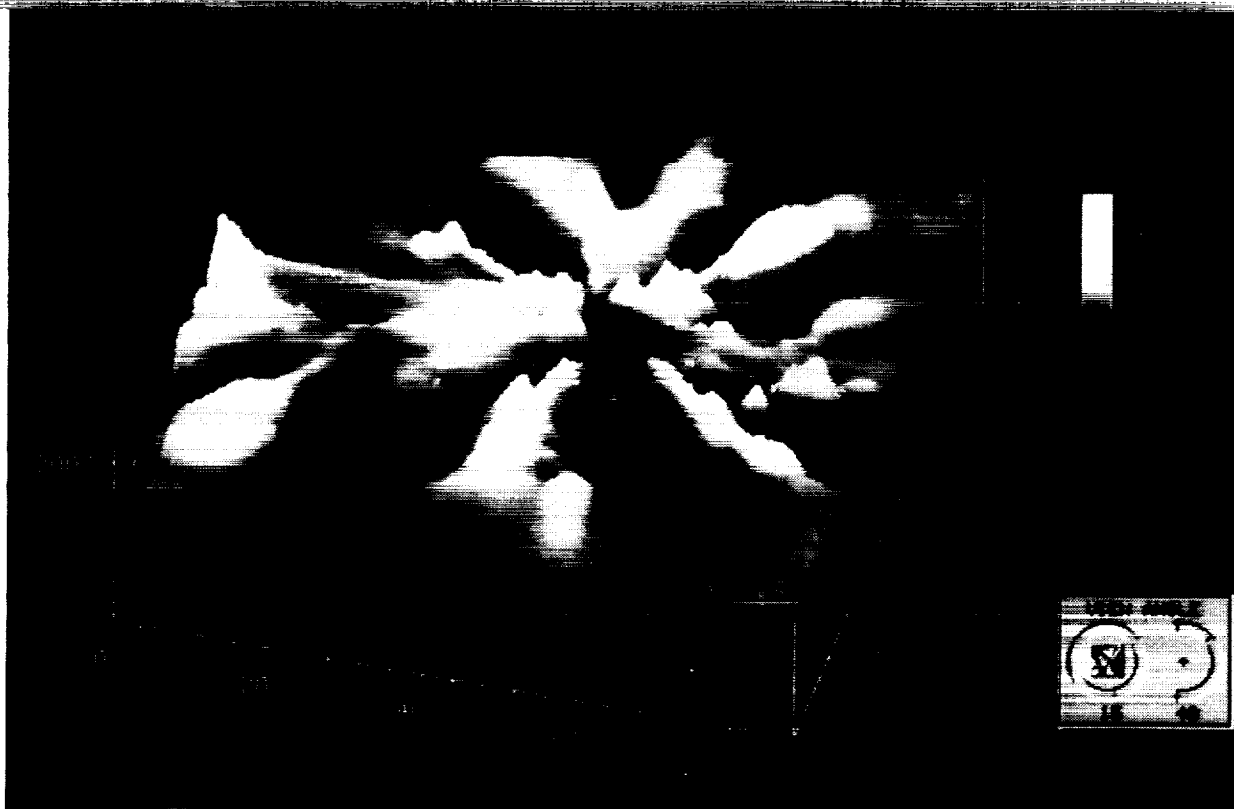
Figures 12a and 12b show optical and AFM images of one of four sites found on trailing-edge sample T6-VI-7-30-36. The crater is irregular in shape and about 1 μm deep. Melted material estimated by AFM to be 2000 Å thick is spewed in a radial fashion from the impact site. SIMS analysis in the region of two other impact sites (smaller craters) on this sample identified Cu, Al, Na, K, and siloxane contaminants. The Cu probably originated from diamond-turned Cu mirrors in the sample module.

Figure 12b. Atomic force micrograph of secondary impact site in Figure 12a. The melted material
around the impact site is an estimated 2000 Å thick.

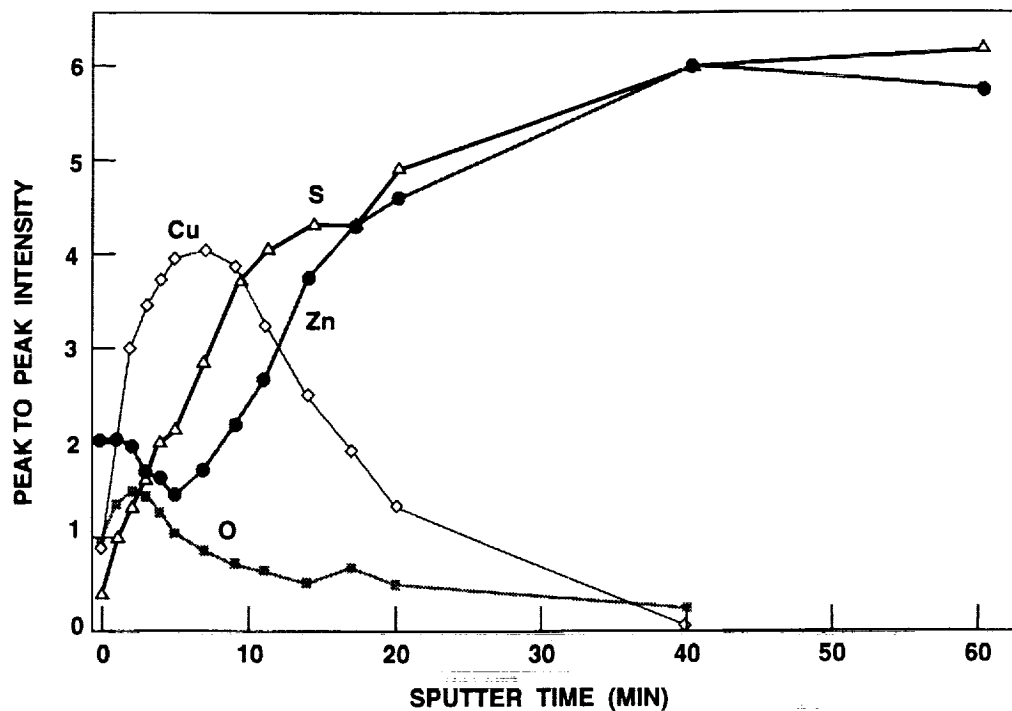
A high-contrast SEM image and scanning Auger analysis of a dendrite described earlier[1] suggest a reaction with Cu to form a CuZn or CuZnS alloy. An Auger depth profile (Figure 14) taken in a region of dendrites gives a direct indication of a displacement reaction between Cu and ZnS. This profile also shows that O has to some extent replaced S in the ZnS. The thickness of the "alloy" and oxide is estimated from the sputter time to be about 400 Å. A mass-resolved SIMS image of a dendrite at an Al-contaminated site on the leading-edge ZnS/ThF$_4$ test sample is shown in Figure 15.

Figure 14. Auger depth profile showing Cu and O reaction with ZnS surface layer in dendrite region of leading-edge test mirror, L6-VI-7-68-15. (Auger depth profile courtesy of T. Beirling and R. Helms, Stanford University.)

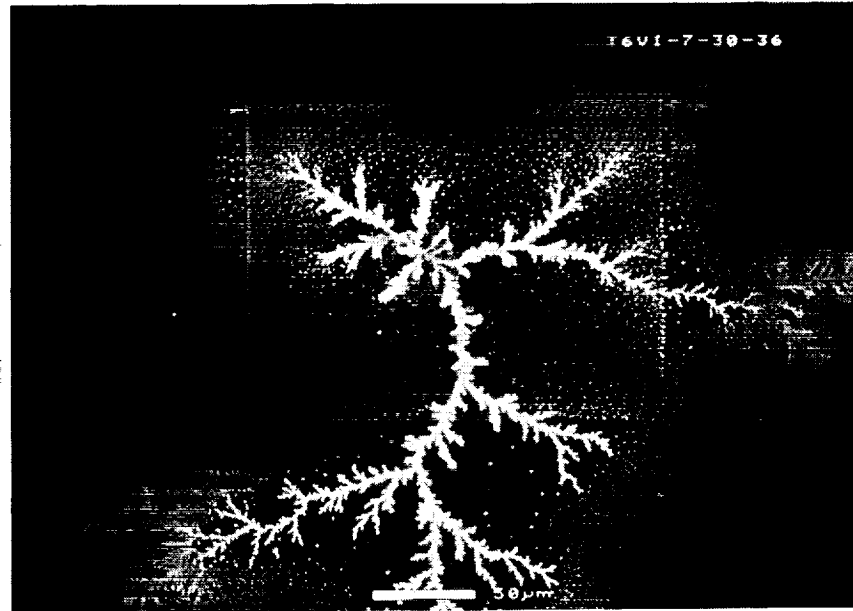
No dendrites were found on the trailing-edge sample, but they could be grown in the laboratory by rastering an electron beam in the vicinity of an impact site. The electron-stimulated growth of dendrites was recorded on video tape. An SEM image of a dendrite grown by electron irradiation is shown in Figure 16. The spherical particles, shown in the figure, appeared as a result of electron irradiation. The depletion of these "clusters" in the vicinity of the dendrite suggests a diffusion-limited growth process. Nucleation and growth possibly initiated at the small damage site in the upper left branch of the dendrite shown in Figure 16.

Figure 15. Mass-resolved SIMS image of a dendrite on the leading-edge ZnS-coated test mirror, L6-VI-7-68-15. The bright areas show high concentrations of Al contamination.

Figure 16. Scanning electron micrograph of dendrite grown in the laboratory on trailing-edge ZnS-coated test mirror, T6-VI-7-30-36. Growth was stimulated by electron irradiation in the region of a secondary impact.

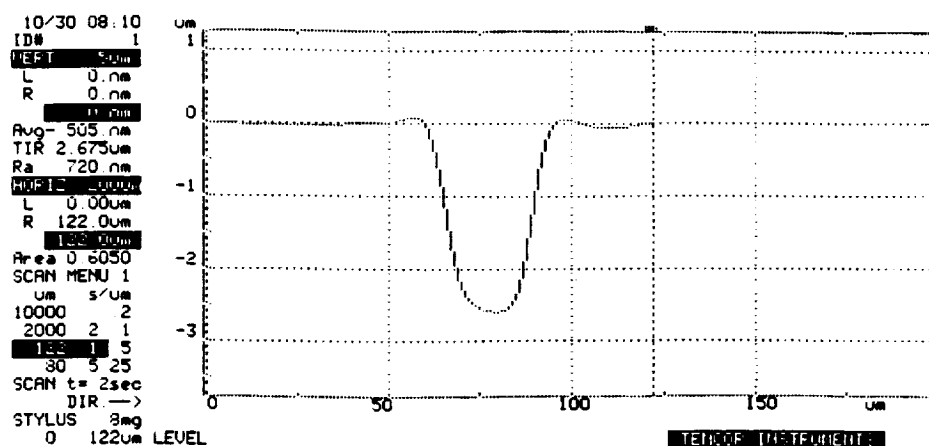
Finally, several crater-like features were found in the ion-raster patterns during profiling-SIMS measurements of sample L6-VI-7-68-15. A raster pattern with small crater-like features is shown in Figure 18a. A profilometer trace through one of the craters is shown in Figure 18b. The crater is 40 μm in diameter and about 2.4 μm deep. The "craters", which were observed after profiling, developed when a 14.5 kV, 0.1 to 0.7 mA Cs^+ primary ion beam was rastered over a square region 500 μm on a side.

Figure 18b. Profilometer trace through one of the small crater-like features in Figure 18a.
